**FACILITIES INSPECTION REPORT**

## INSPECTION REPORT

Southern California Waste Water  
(formerly known as Santa Clara Waste Water)

Date of Inspection: June 9, 2014

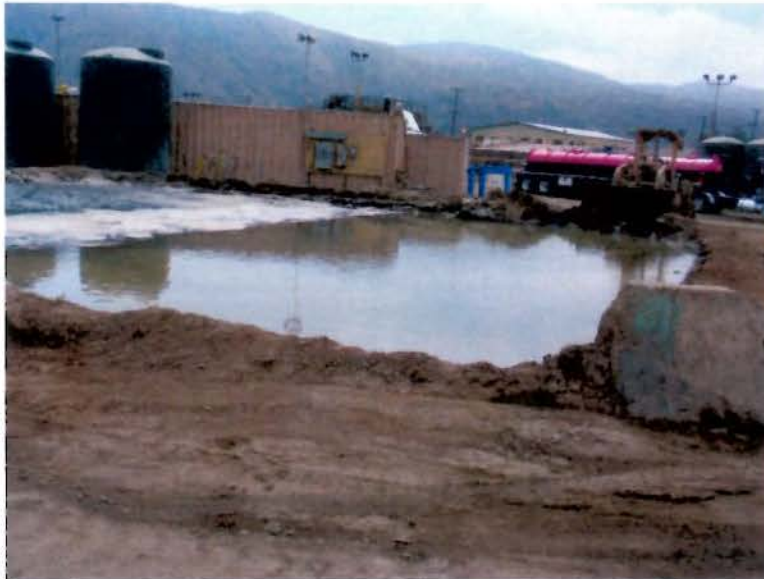
The facility has a large holding pond (40 feet long by 40 feet wide by 5 feet deep) filled with process water (or leachate from landfill) at the southwest portion of the site (Picture 1). A smaller holding pond (15 feet long by 13 feet wide by 2 feet deep) is located approximately 50 feet to the south of the large pond that also contains process water (Picture 2). According to Mr. Mundy, these ponds are lined with concrete at the bottoms but not the sides. However, the berms are constructed with sediment soils.

The facility has two holding ponds with wastewater in them. Although these ponds are lined with concrete at the bottoms, the berms are not concrete lined. Therefore, there is potential for the wastewater to percolate to the groundwater.

Picture 1 – View of the large holding pond filled with process water (or leachate from landfill) at the southwest portion of the facility. The dimension of this pond is 40 feet long by 40 feet wide by 5 feet deep.

The facility currently is not enrolled under Waste Discharge Requirements (WDR) for its holding ponds. Therefore, Regional Board staff will require the discharger to submit an application for WDR. In addition, Regional staff will ask for the design of the ponds

because even though they are concrete lined at the bottoms, the water in the ponds may still percolate to groundwater from the sides and cause impact.

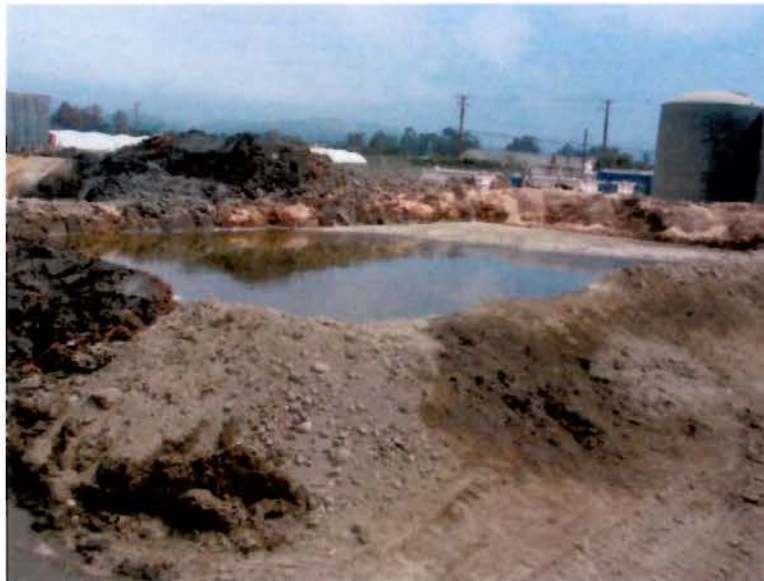
Picture 2 – View of the smaller holding pond located approximately 50 feet to the south of the large pond that also contains process water. The dimension of this pond is 15 feet long by 13 feet wide by 2 feet deep.

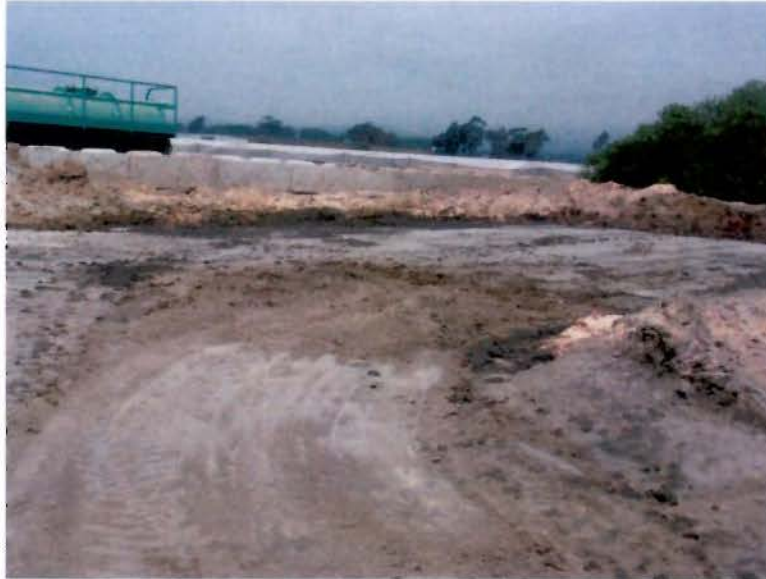
There is also a third pond at the southeast portion of the facility. This pond (15 feet long by 17 feet wide by 2 feet deep) is dry and is not being used (Picture 3). One of the berms of the pond has already been demolished.

Picture 3 – View of the dry pond at the southeast portion of the facility. The dimension of this pond is 15 feet long by 17 feet wide by 2 feet deep and it is not being used currently. One of the berms of the pond has already been demolished.

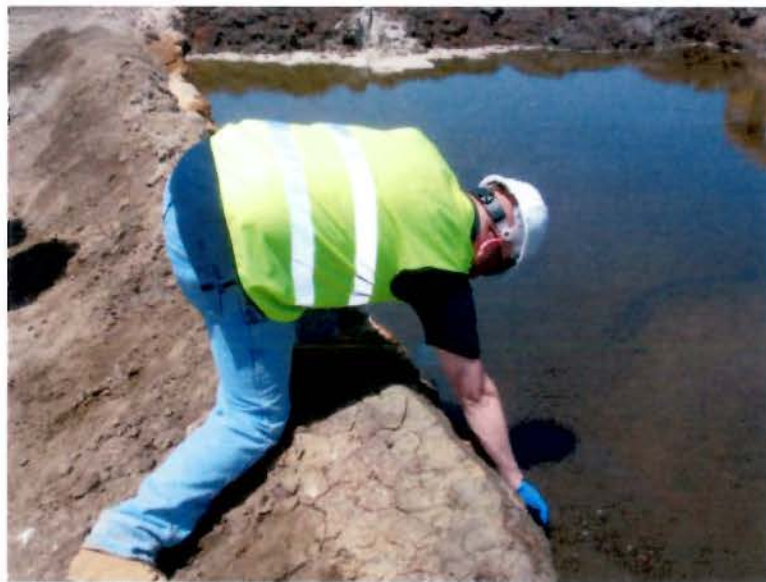
Regional Board staff Enrique Loera took samples (Pictures 4 and 5) from the smaller holding pond for laboratory analysis.

Picture 4 – Regional Board staff Enrique Loera taking wastewater samples from the smaller holding pond for laboratory analysis.

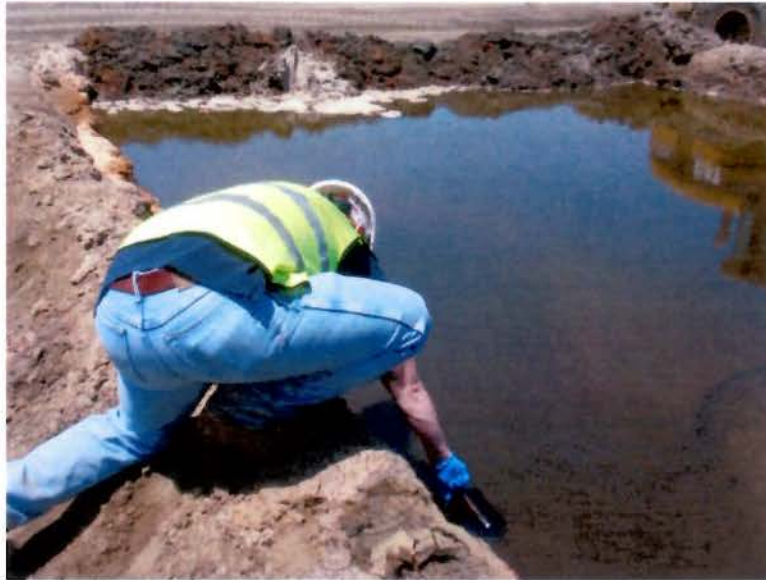
Picture 5 – Another view of Regional Board staff Enrique Loera taking wastewater samples from the smaller holding pond.
